Kingfisher Pond - Northstowe Hydrogeological Assessment

Phase II Report

FWM8714-RT002-R02-00

May 2021

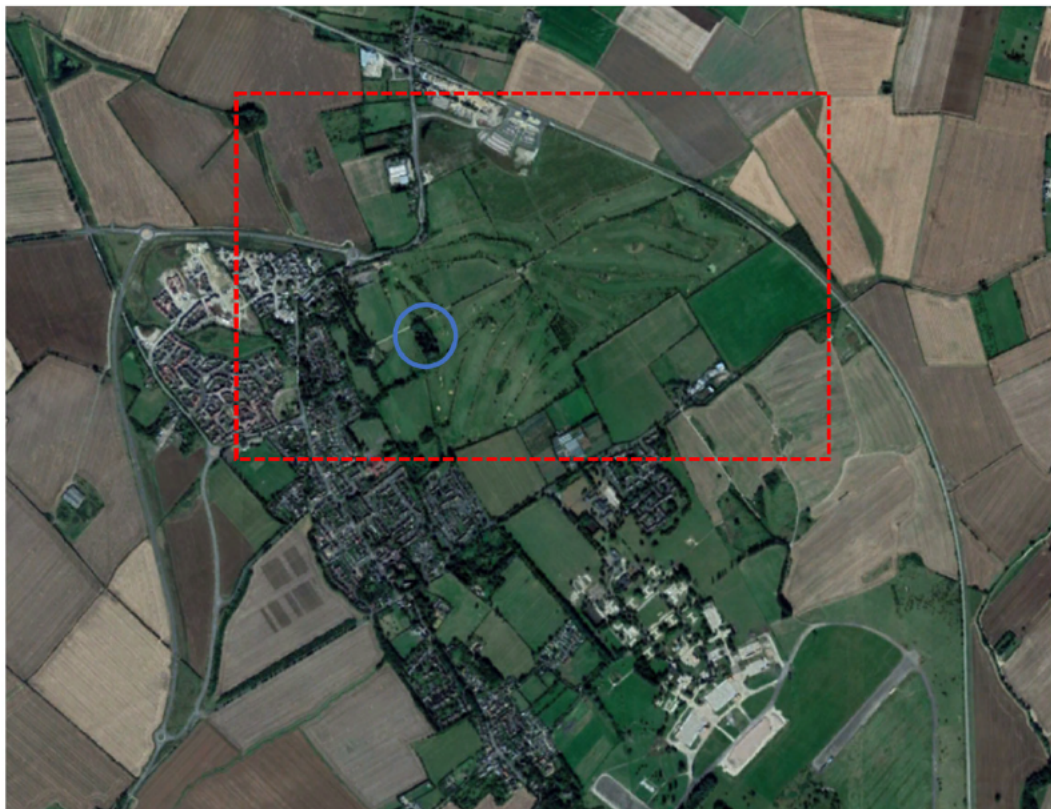
To highlight the scale of the land use change of the local area, Figure 4.2 and Figure 4.3 show a satellite map of the local area pre Northstowe development in September 2012 and in May 2020. The contrast of the two images highlight the scale of the development of Northstowe and the change from undeveloped land to the current state of development. This has important implications for surface run off and for infiltration of surface water into the RTD. Increased urbanisation will reduce recharge to the RTD unless there is a sufficient surface drainage plan to allow the run-off to infiltrate the soil and recharge the RTD. This is further discussed in Section 4.2.4.

Figure 4.2: Satellite imagery of Longstanton and Northstowe, September 2012. The location of the Kingfisher Pond is highlighted within the blue circle. The approximate area of Northstowe Phase 1 is highlighted by the red dotted line

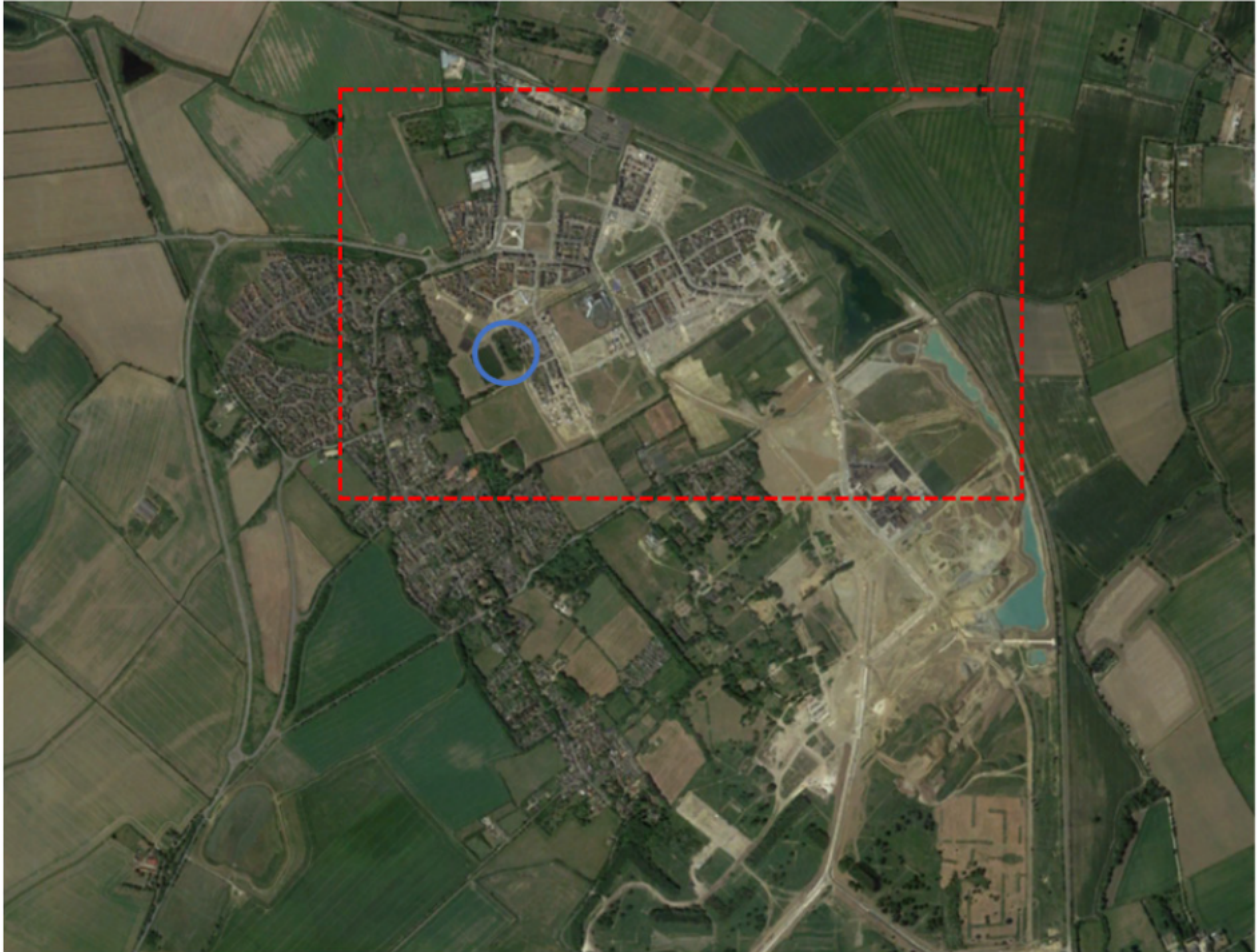
Figure 4.3: Satellite imagery of Longstanton and Northstowe, May 2020. The location of the Kingfisher Pond is highlighted within the blue circle. The approximate area of Northstowe Phase 1 is highlighted by the red dotted line

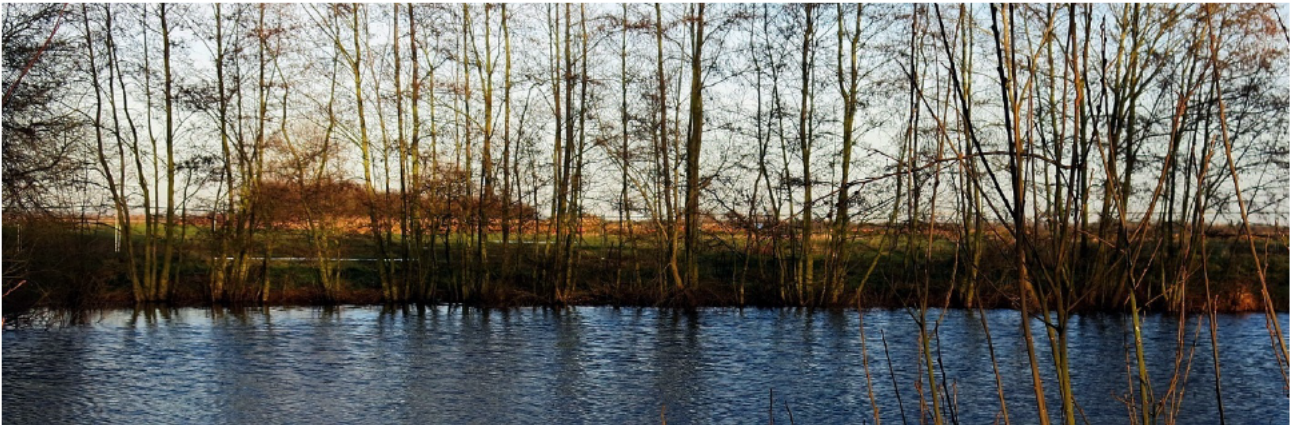
Photograph 5.1 shows the Kingfisher Pond in January 2015. Water levels are considered to be within the pond's natural range.

Photograph 5.1: The Kingfisher Pond, January 2015

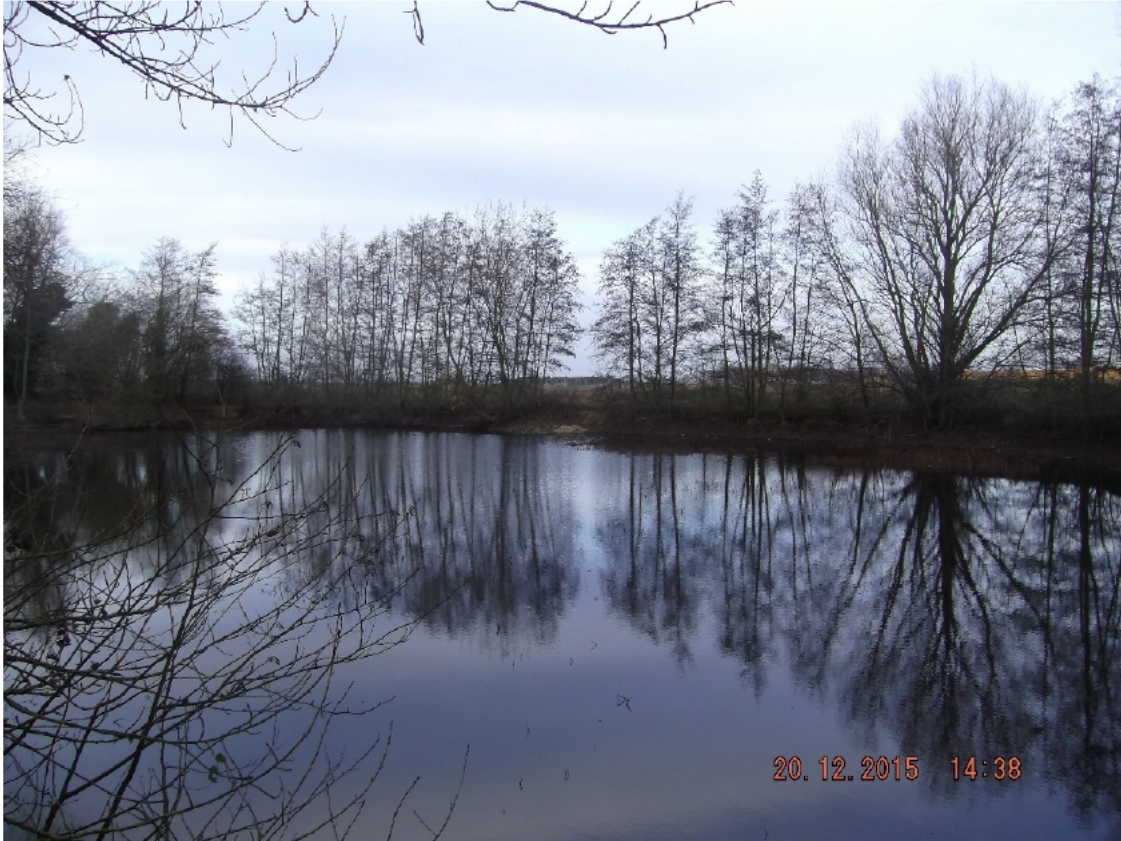
The first documented concerns of the change in the Kingfisher Pond were raised in December 2015. Photograph 5.1 shows the state of the pond at this time. The water levels have visibly dropped since the previous winter, exposing the banks of the pond.

Photograph 5.2: The Kingfisher Pond, December 2015

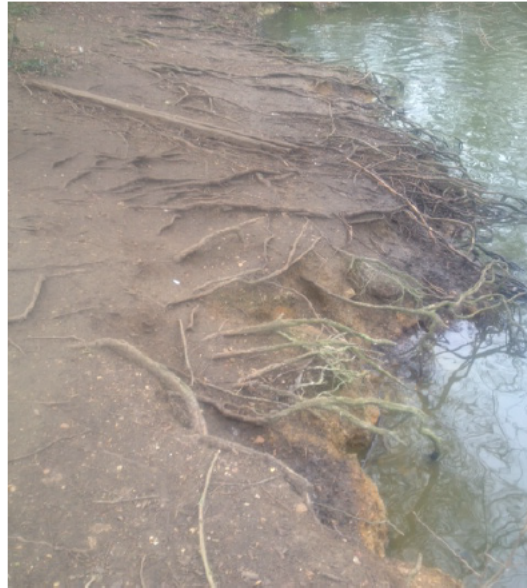
The water levels in the Kingfisher Pond continued to decline in the winter of 2015/16 and spring of 2016 (Photograph 5.3 , Photograph 5.4). Tree roots are visible exposed indicating the extent of water level decline.

Photograph 5.3: The Kingfisher Pond, March 2016

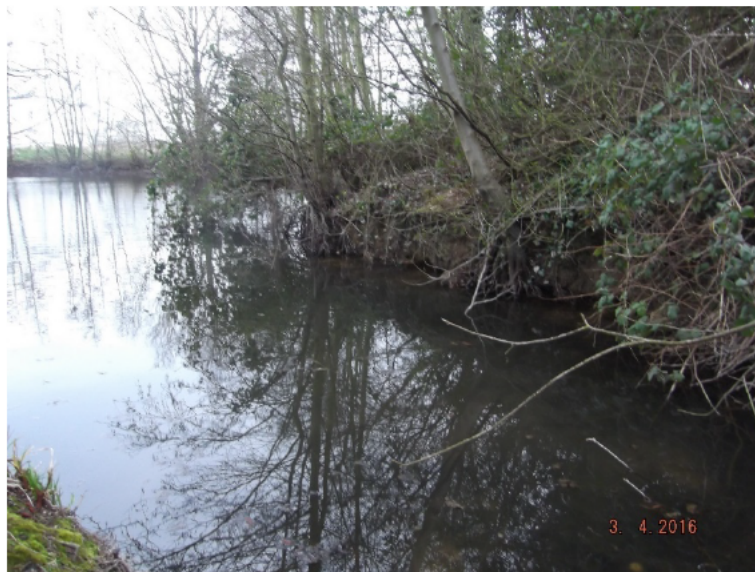
Photograph 5.4: The Kingfisher Pond, April 2016

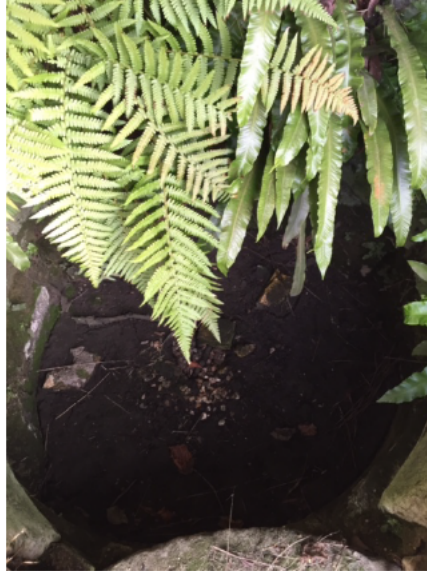
Holy Well, situated in St Michael's churchyard, is supplied by the RTD aquifer. The well has historically been used for baptisms. The water levels in this well completely dried out in 2016 as documented in Photograph 5.5.

Photograph 5.5: Holy well, St Michael's church

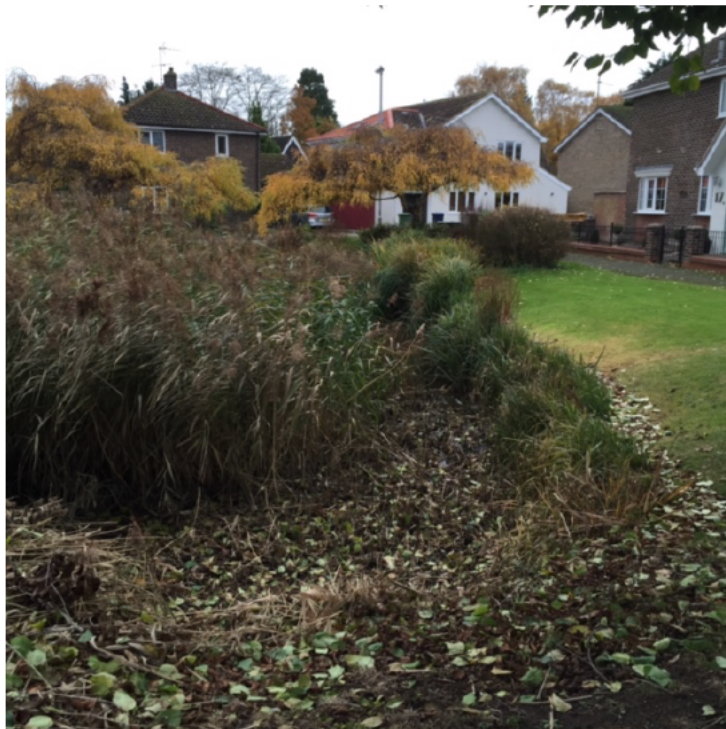
Lady Walk Pond, situation in a residential cul-de-sac, also reported low water levels in summer 2016. Photograph 5.6 shows the condition of Lady Walk Pond in autumn 2016.

Photograph 5.6: Lady Walk Pond, autumn 2016

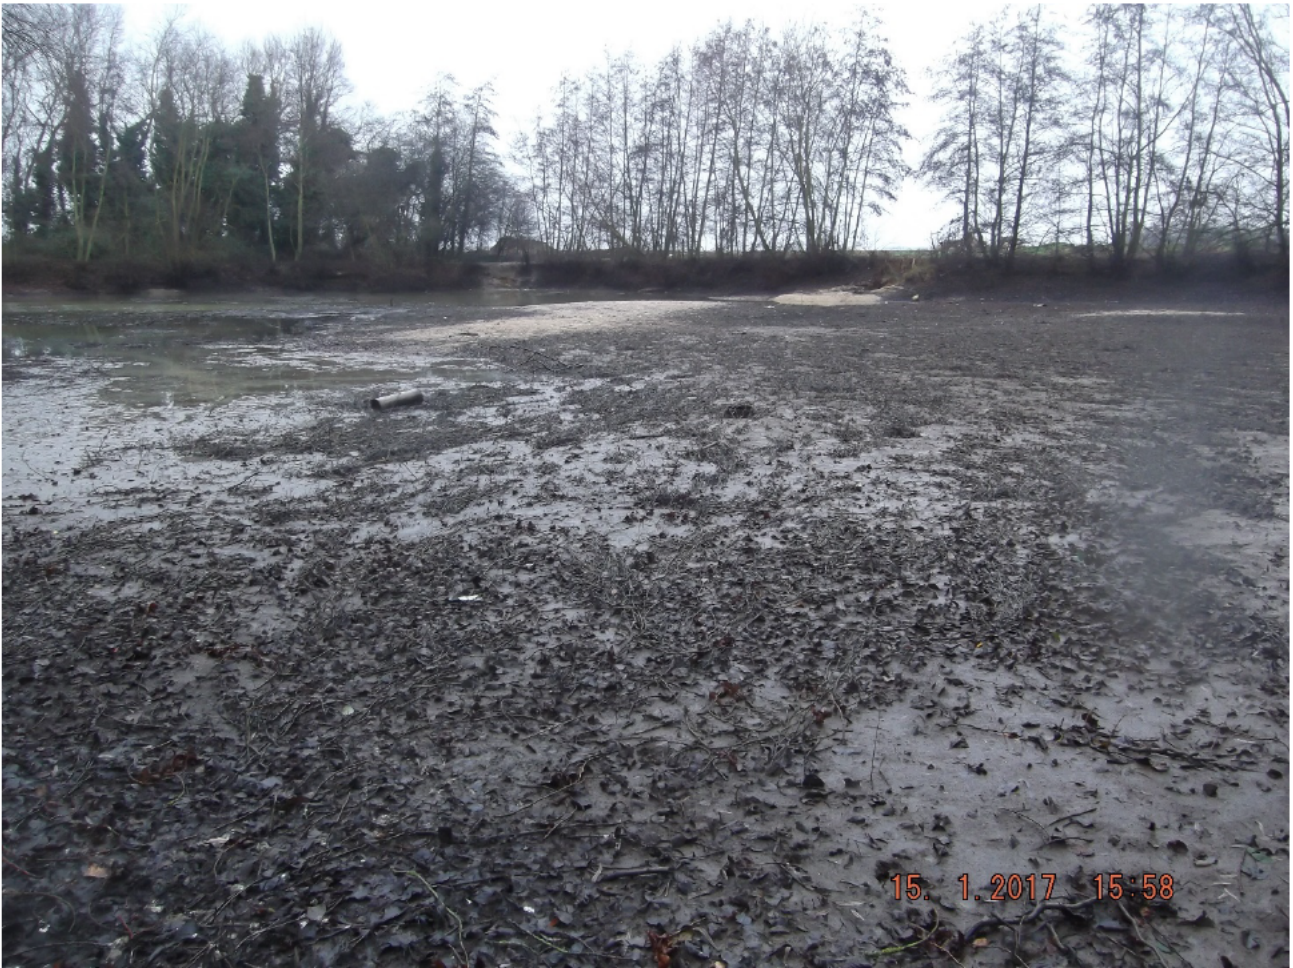
In January 2017, the Kingfisher Pond was completely dried out as shown in Photograph 5.7. This photograph also highlights the depth of the pond to be relatively shallow, between approximately 1 m and 2 m.

Photograph 5.7: The Kingfisher Pond, January 2017

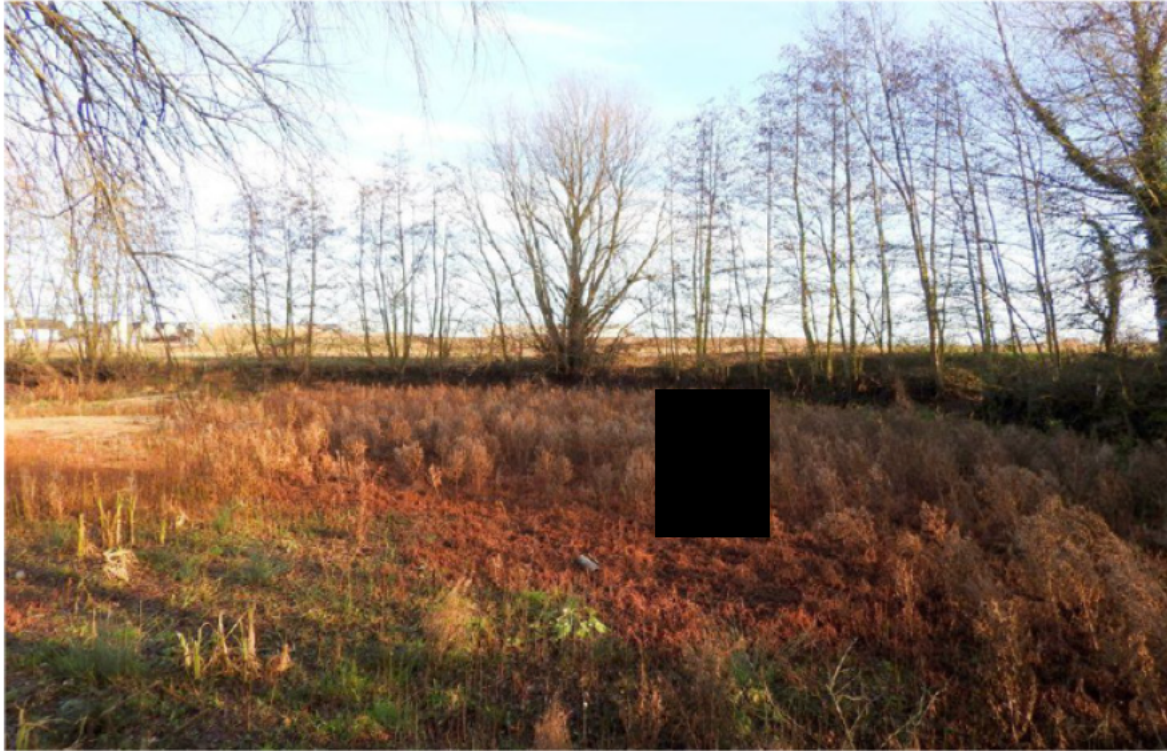
In December 2017, the Kingfisher Pond was completely dry (Photograph 5.8) This was comparable to the previous winter. The overflow pipe which normally allows water to run from the Kingfisher Pond into the drainage system was likewise dry.

Photograph 5.8: The Kingfisher Pond, December 2017

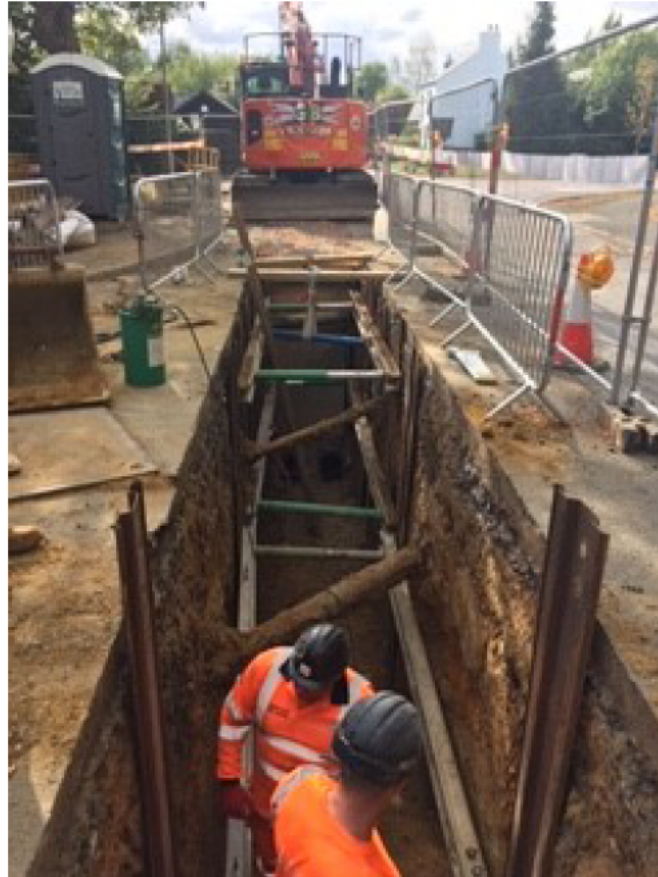
Photograph 5.9 of construction works in September 2019 shows that the groundwater level is not visible. The depth of the trench is approximately 1.5 m to 2.0m below surface level, indicating that the groundwater elevation is below this level.

Photograph 5.9: Northstowe construction, September 2019

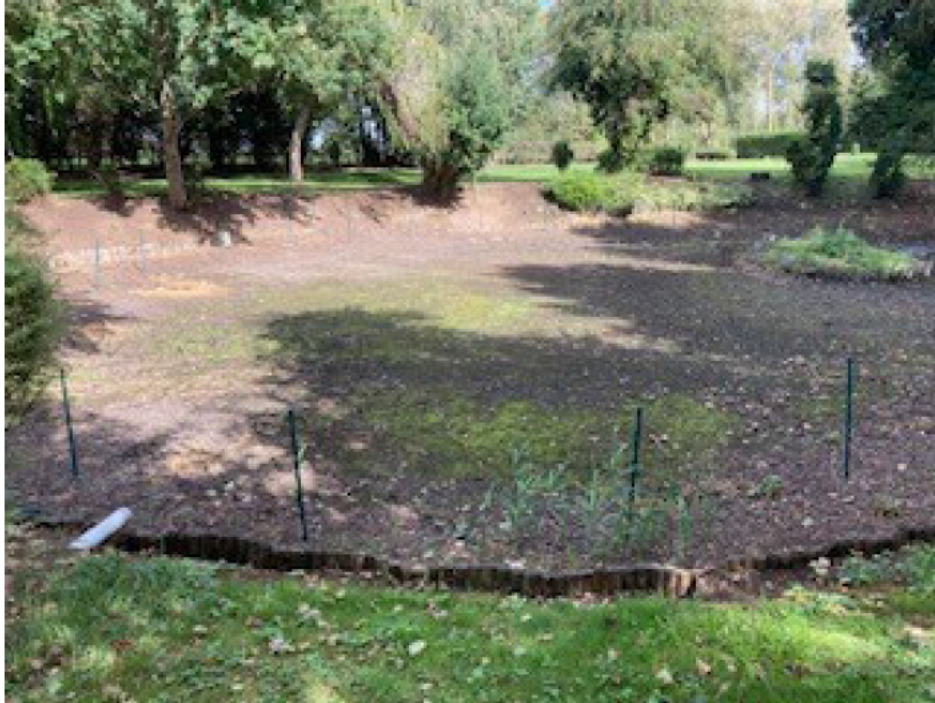
Photograph 5.10 is of a pond located on private property in St Michael's street in August 2020. This pond has been reported by the owners to have completely dried. It has been in this condition for several years. The depth of the pond is approximately 1.5 m.

Photograph 5.10: Private pond located on St Michael's street, August 2020

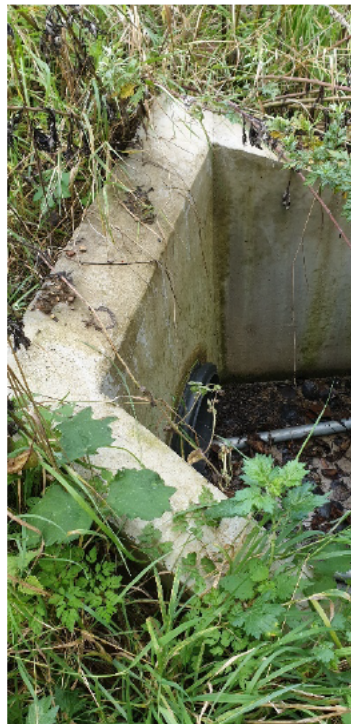
Photograph 5.11 is of the Kingfisher Pond overflow pipe. This pipe was installed in 2019. It allows the Kingfisher Pond to drain into the ditch system when pond levels are high. The overflow pipe has not been required since installation as the water levels in the pond have been below the invert level of the pipe.

Photograph 5.11: Overflow pipe of the Kingfisher Pond, October 2020

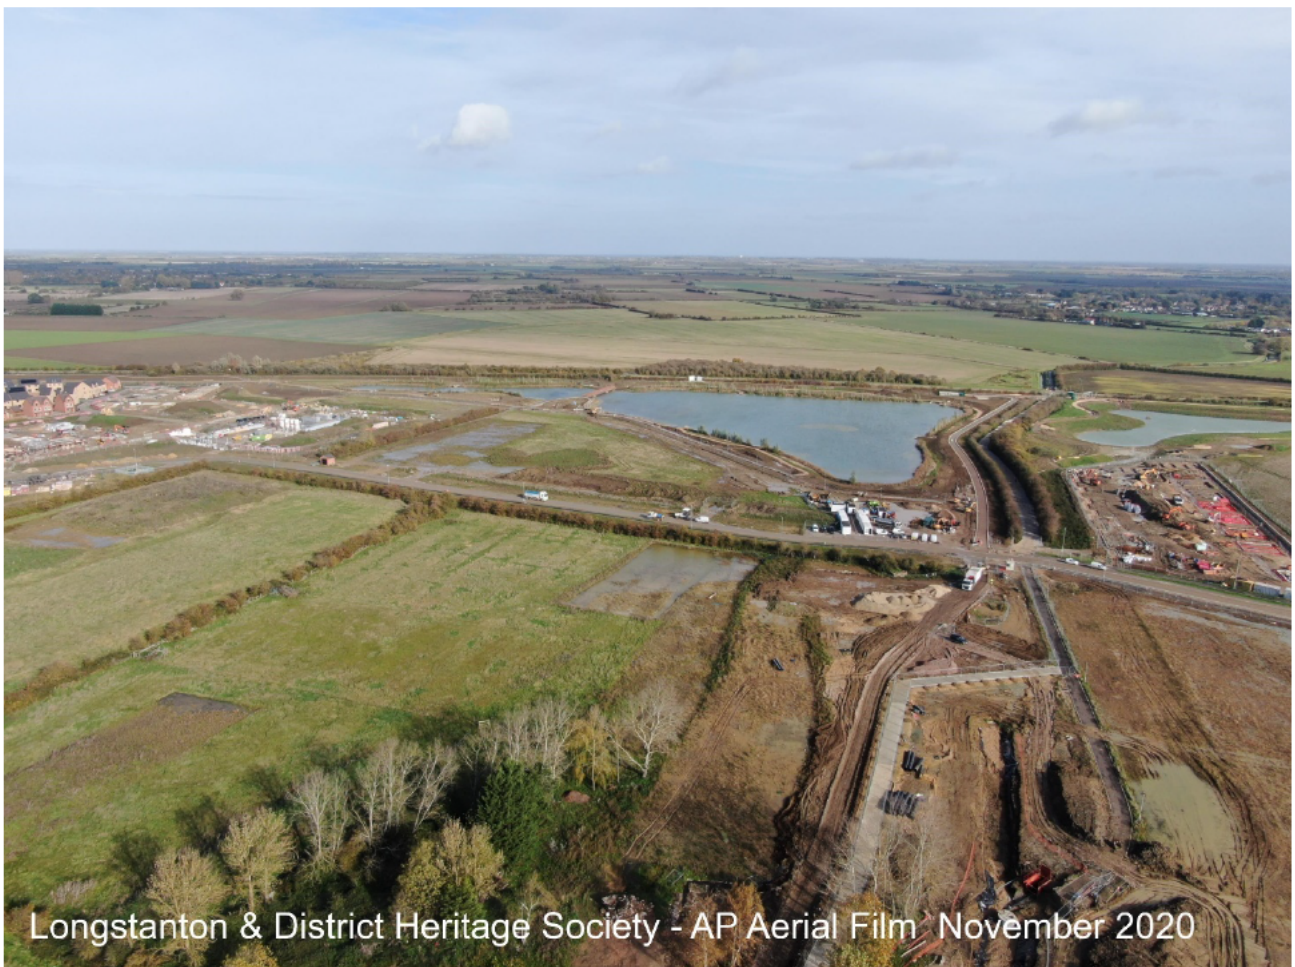
Photograph 5.12: Attenuation Ponds on Phase 1, November 2020

In autumn 2020, aerial photographs of the attenuation ponds on phase 1 (Photograph 5.12) show standing water in the attenuation ponds. As stated in Section 4.2, these ponds form part of the surface drainage strategy of Northstowe and are intended to attenuate surface run off. These ponds are clay lined.

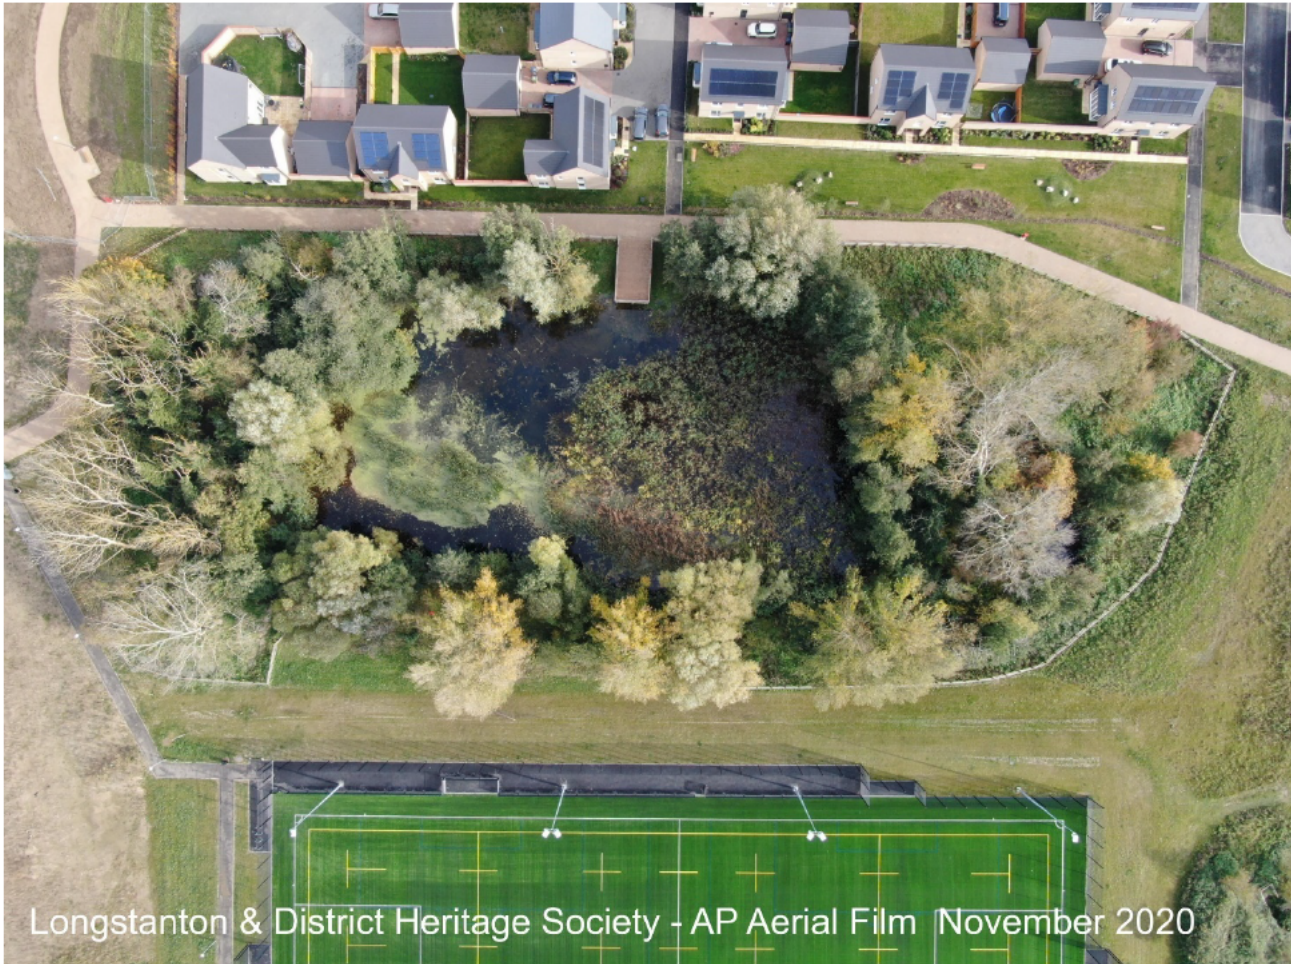
Photograph 5.13 shows the low water level in the Kingfisher Pond in November 2020. The pond is not completely dry as was the case in previous winters of 2016 and 2017. Observational evidence from Longstanton District & Heritage Society suggests that the areas where the pond is directly on the gravel seam are several inches deep and therefore far below normal for this time of year.

Photograph 5.13: The Kingfisher Pond, November 2020

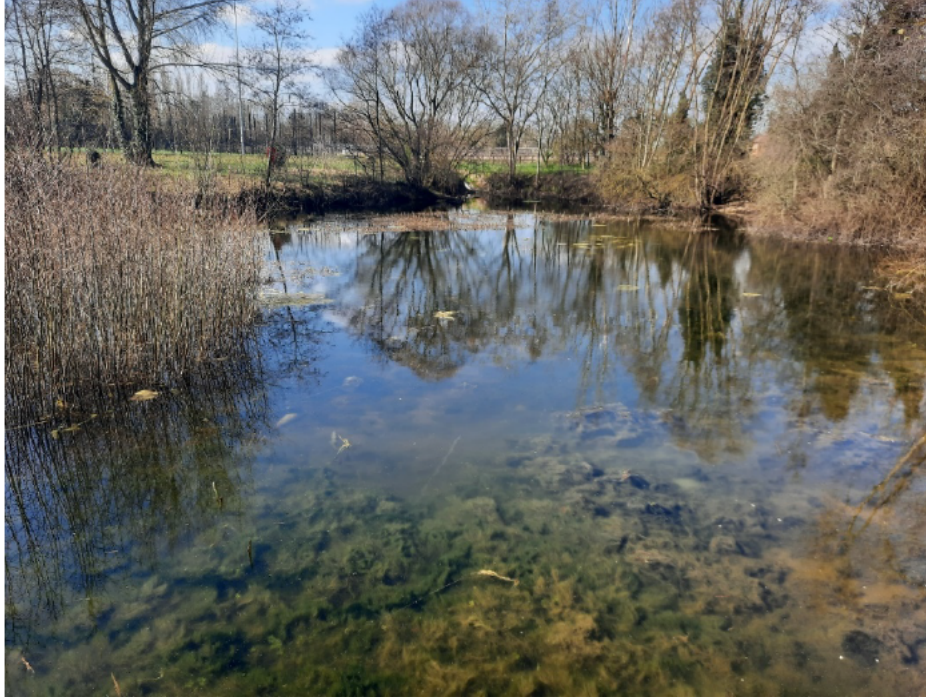
This current state of the pond contrasts with previous reports of the pond having a low water level and previously completely dried out. The pond has therefore visibly recovered. Local residents confirmed that the level of water in the pond was at the highest it had been for several years (circa. 2015). The level of the pond had improved since February 2021.

Photograph 6.1: Kingfisher Pond, March 2021. No.1

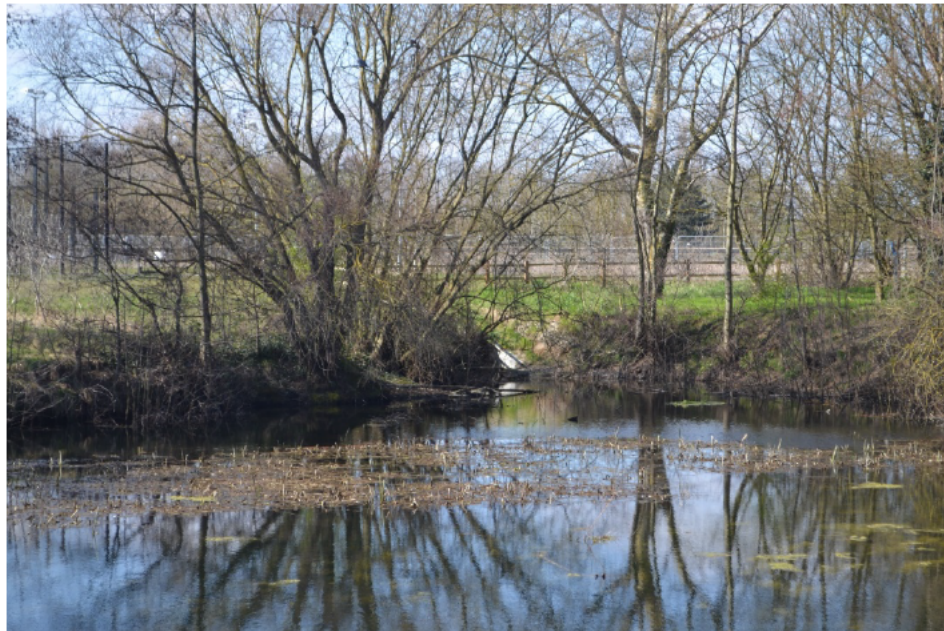
Photograph 6.2: Kingfisher Pond, March 2021. No.2

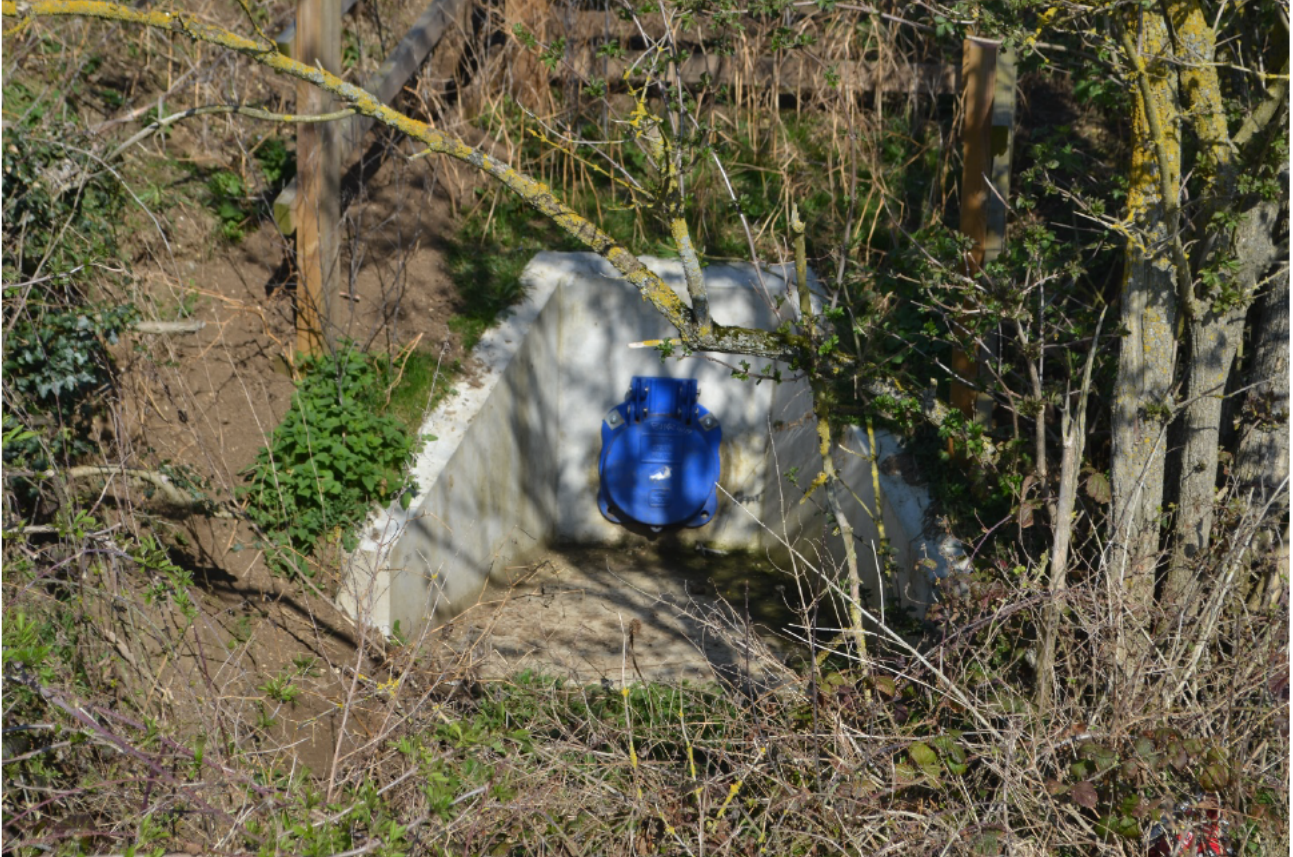
Photograph 6.3: The Kingfisher Pond overflow pipe, March 2021

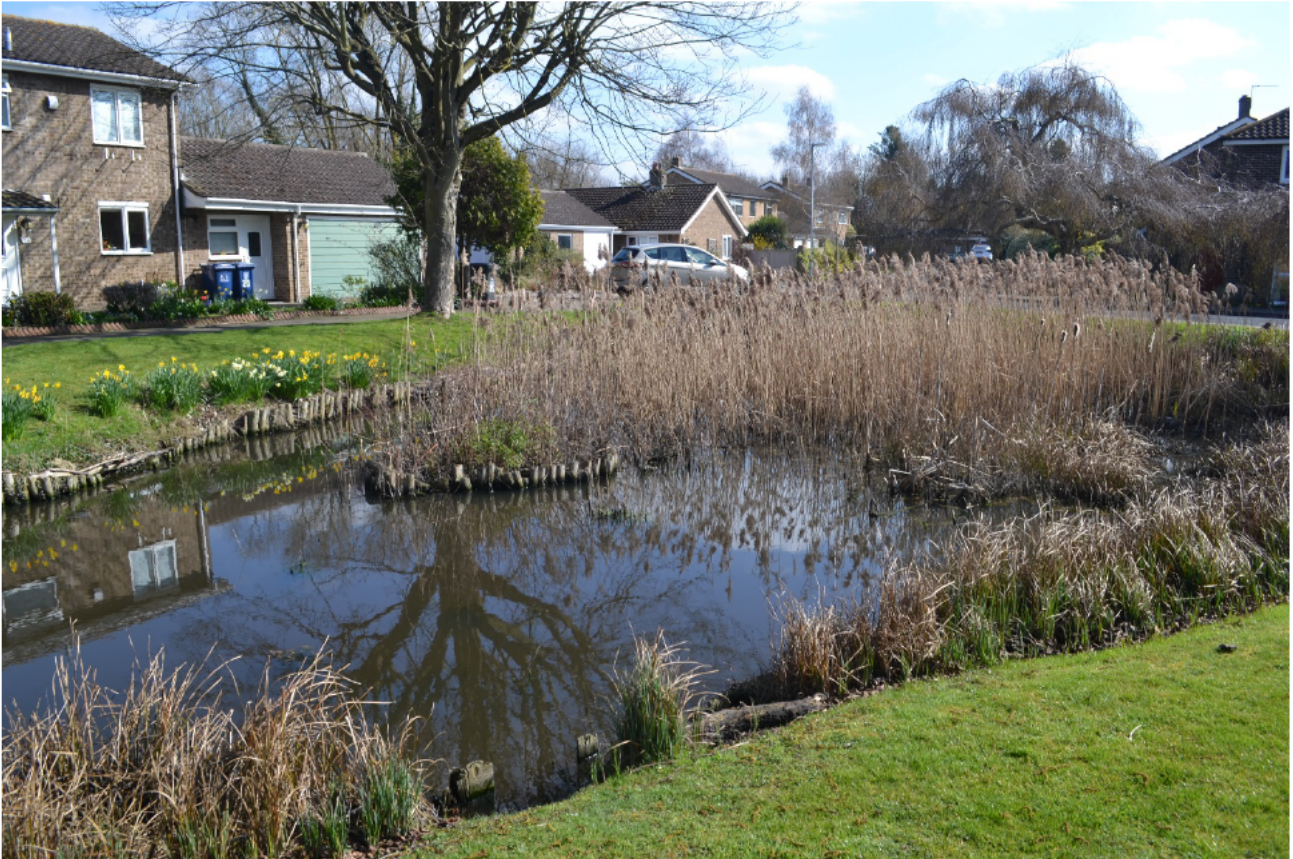
Lady Walk Pond is a small pond situated in the cul-de-sac Lady Walk. As with the Kingfisher Pond, this pond had previously been reported to completely dry out. In January 2021, the pond was completely dry however during the site visit in March 2021 the pond had substantially recovered (Photograph 6.4), This indicates the groundwater levels had risen significantly between February and March 2021. Local residents reported that the Lady Walk Pond was at its highest level since autumn 2015. The pond had abundant reedbeds which indicate a relatively shallow depth approximately 0.5 m to 1.0 m.

Photograph 6.4: Lady Walk Pond, March 2021

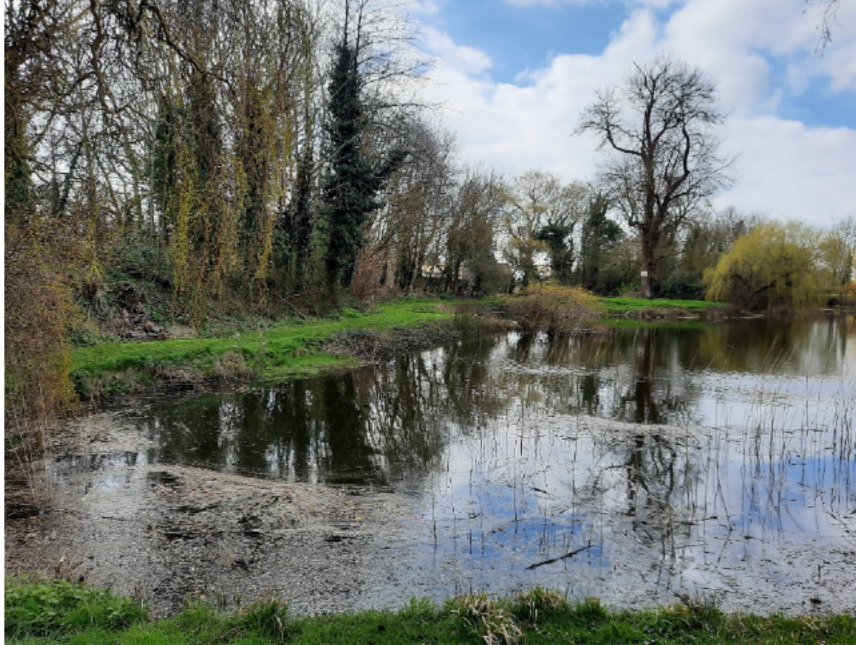
Consistent with the Kingfisher Pond and Lady Walk Pond, Nethergrove Lake had notable increased water levels. [REDACTED] confirmed that the water levels at Nethergrove Lake were at the highest during March 2021 compared with the previous 5 years.

Photograph 6.5: Nethergrove Lake, March 2021. No.1

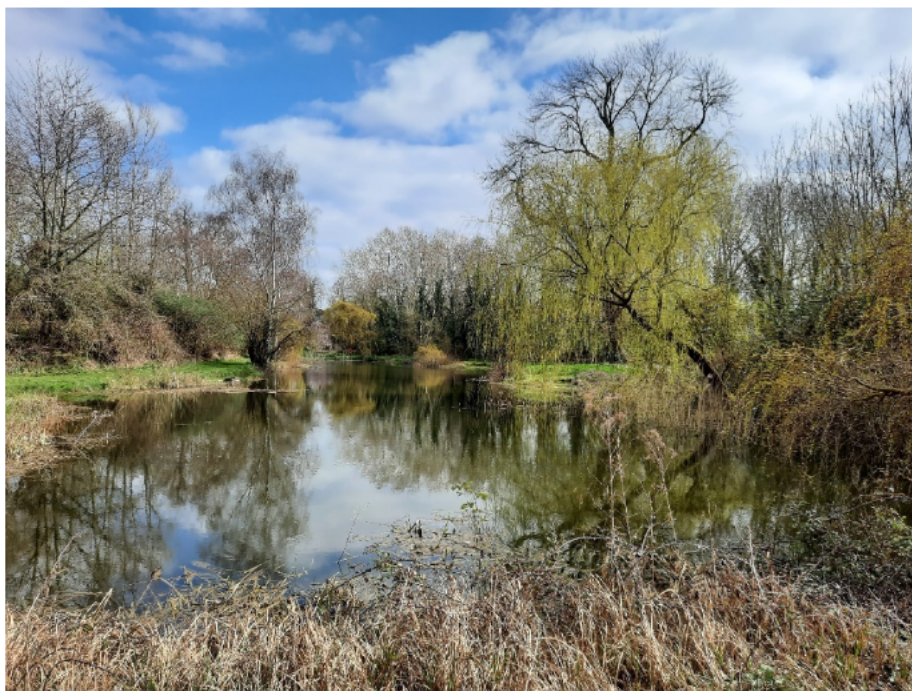
Photograph 6.6: Nethergrove Lake, March 2021. No.2

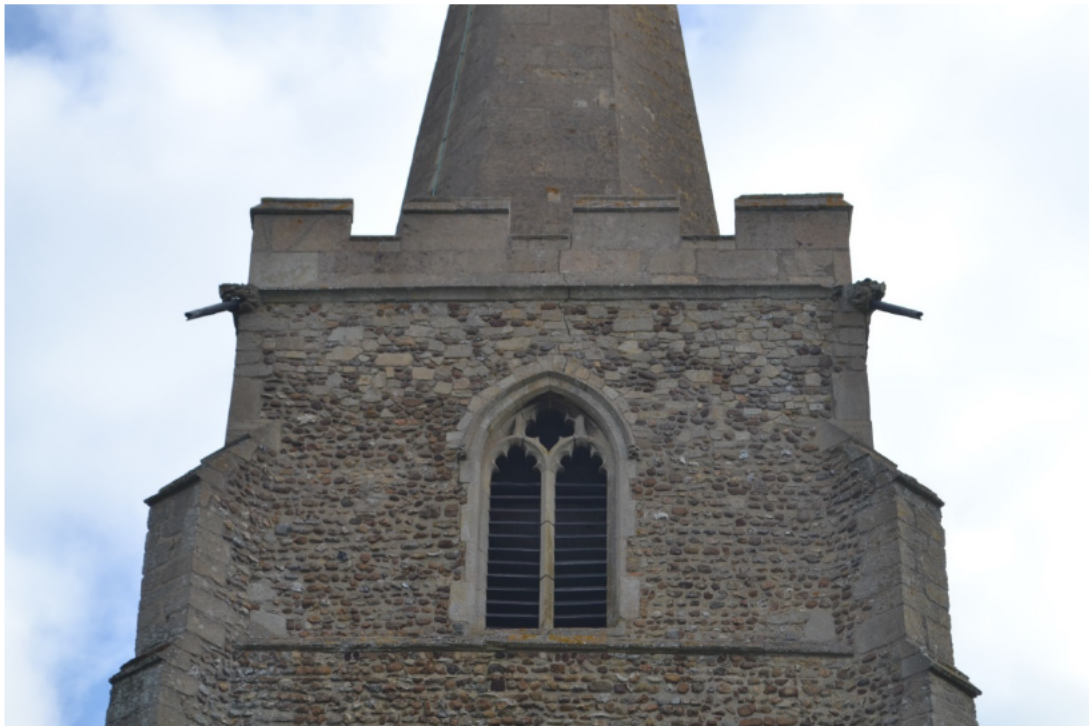
"...the below ground drainage should be checked as there are a number of cracks in the church which are suggesting some kind of movement probably caused by changing subsoil conditions."

Photograph 6.7: All Saints Church. Cracks above the church window are visible in this photograph

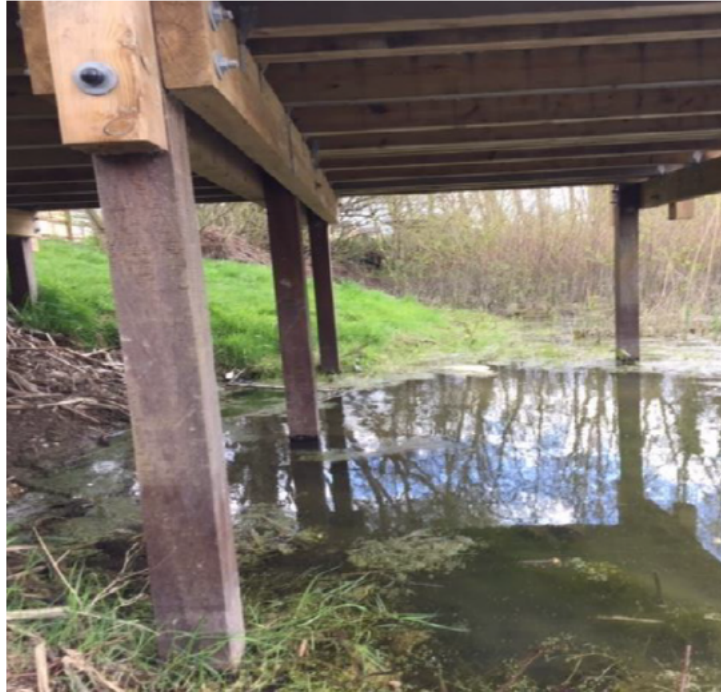
Photograph B.2: Kingfisher Pond jetty, April 2021

The following photos are of the Kingfisher Pond and taken on 15th April 2021. The first four photos of the pond are taken from the jetty side (Photograph B.2, Photograph B.3, Photograph B.4, Photograph B.5).

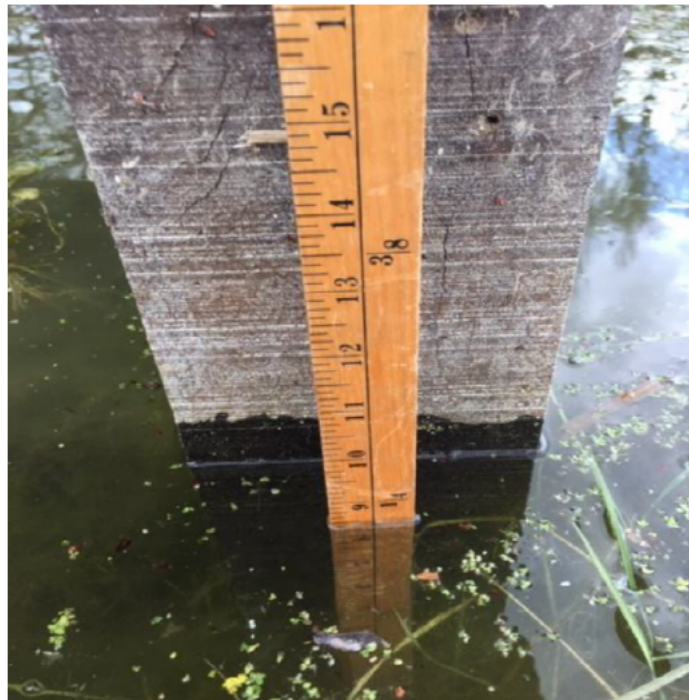
Photograph B.3: Kingfisher Pond jetty with measuring stick, April 2021. The water next to the outermost jetty post measured 9 inches

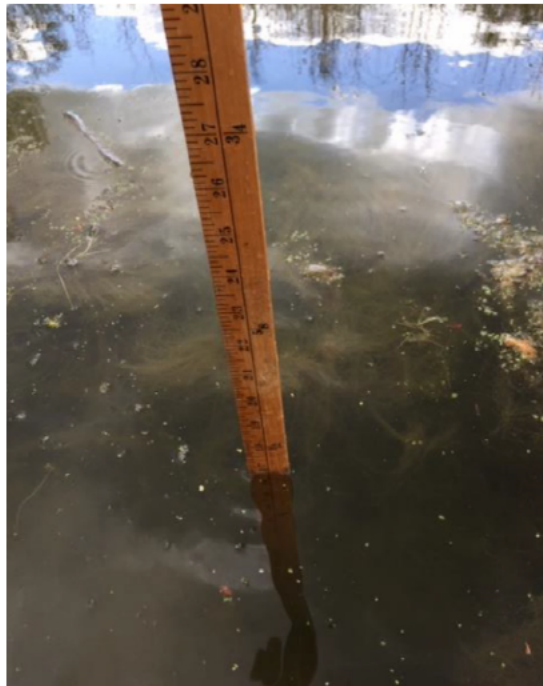
Photograph B.5: Kingfisher Pond with measuring stick, April 2021

Notes: *This measurement was taken as near the centre as I could reach with my boots on. This measurement is 17 inches.*

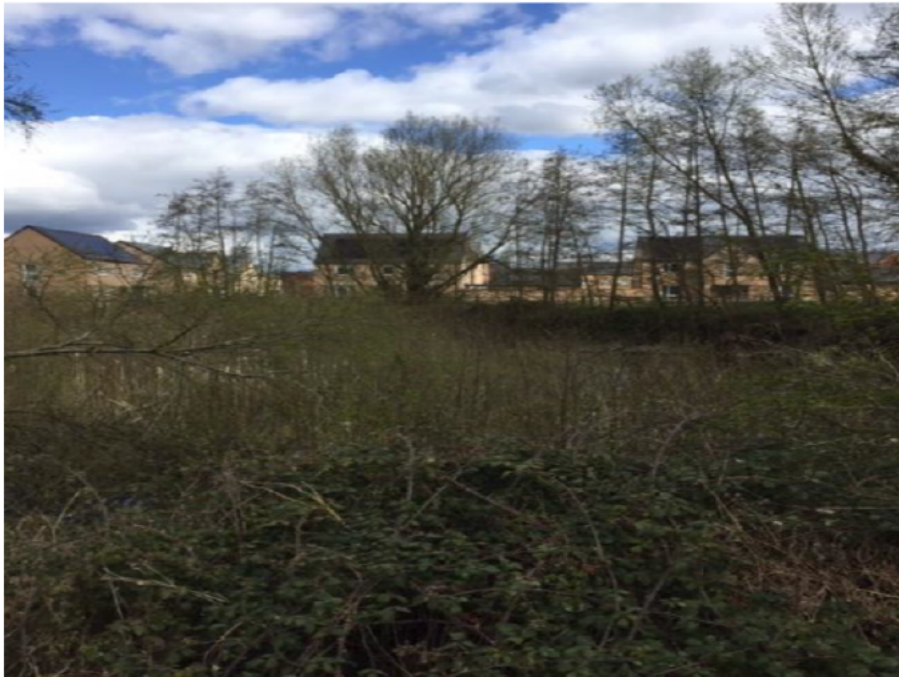
Photograph B.6: The Kingfisher Pond, April 2021

The following three photos (Photograph B.6, Photograph B.7, Photograph B.8) are taken from the side of the pond opposite the jetty. This was the side from which the 2014 photograph of the dog was taken (Photograph B.1).

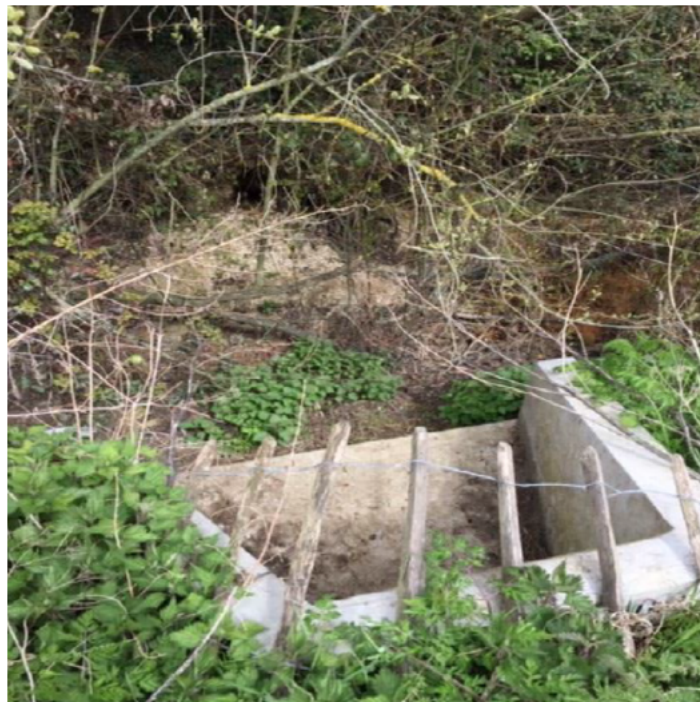
Photograph B.8: The Kingfisher Pond overflow pipe. April 2021
